SALMONBERRY BRIDGE REHABILITATION

Tillamook County, Oregon

In August 2012, the installation of Bridge Preservation's waterproofing system was completed for the Oregon DOT's Salmonberry Bridge in Tillamook County, Oregon.

Project Information
Project Number: 14364
Owner: Oregon DOT
Project Size: 5,760 SF
Date of Installation: August 2012

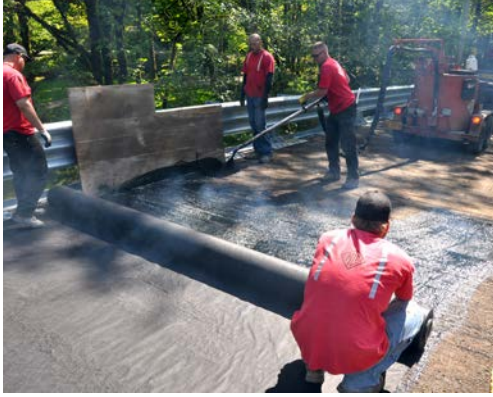
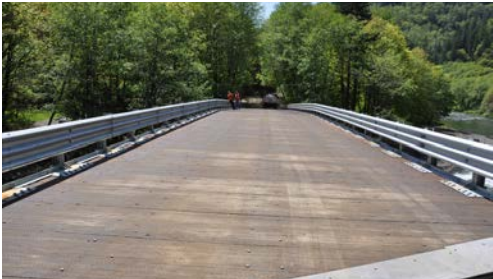
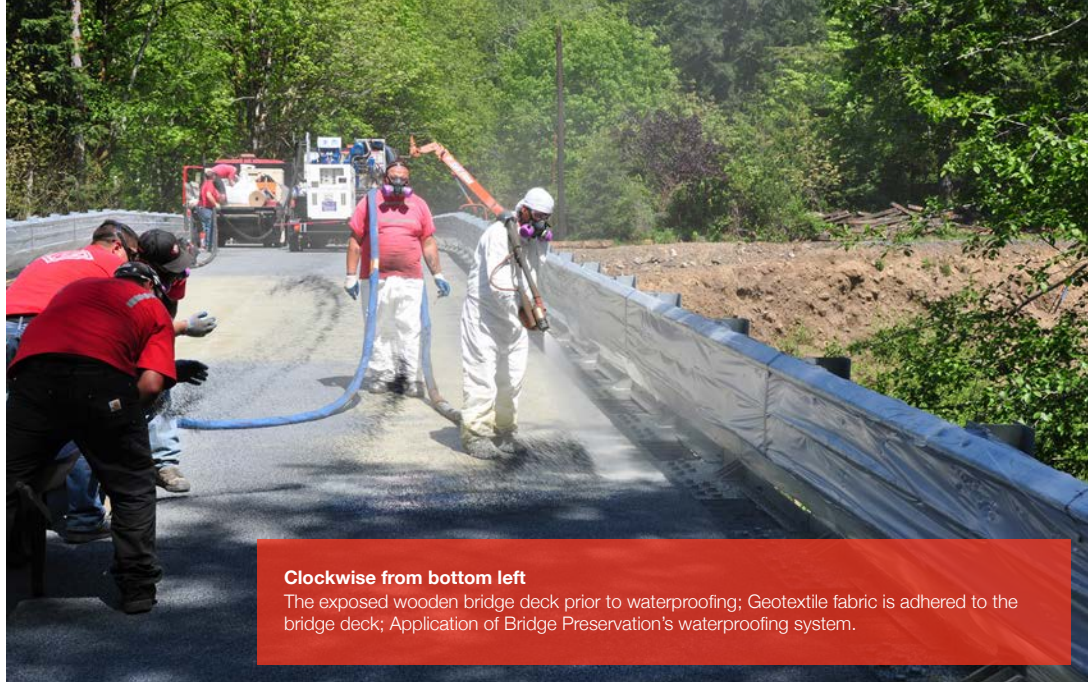
Clockwise from bottom left
The exposed wooden bridge deck prior to waterproofing; Geotextile fabric is adhered to the bridge deck; Application of Bridge Preservation's waterproofing system.

The project began by milling off the existing asphalt to expose the underlying wood deck. After milling, a geotextile fabric was adhered to the deck. Immediately following the placement of the geotextile fabric, primer was applied to the entire deck surface. Approximately 30 minutes after the primer application, a base coat of Bridge Preservation's Bridge Deck Membrane was applied at 80 mils.

Upon completion of the base coat application, an additional 40 mils of membrane was sprayed to provide a medium to set broadcast aggregate. The purpose of this aggregated top coat is to provide additional shear bond strength between the asphalt and the waterproofing membrane.

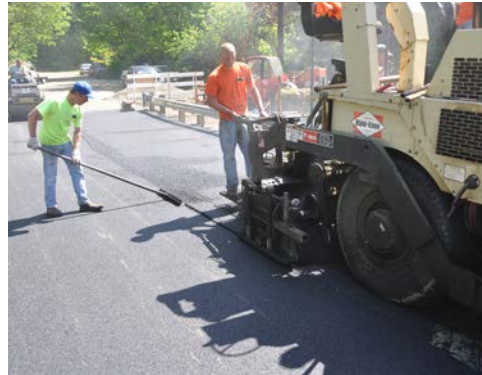
Application of Asphalt
The asphalt wear course is applied approximately one hour after the application of the waterproofing membrane.

After one hour, the asphalt wear course was applied. As soon as the asphalt was cooled, the now completely waterproofed bridge was back in service.

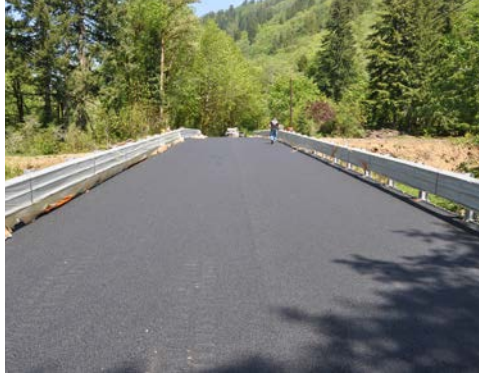
Project Complete
The bridge deck is now completely waterproofed and paved.
