FAP-330, US RT 45 Approx. 1800' N of 143rd St. in Village of Orland Pk.

Orland Park, IL

Project Information
Project Number: 60K64
Owner: Metra/Illinois DOT
Project Size: 6,994 SF

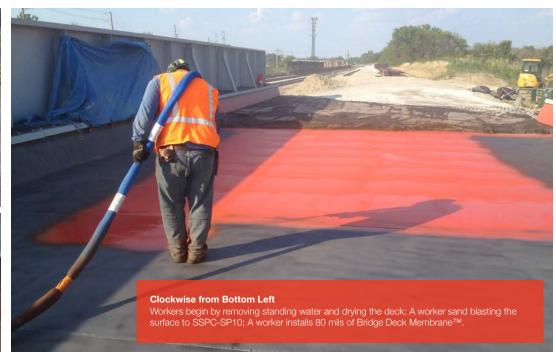
Typical Adhesion Testing ResultsPull test results of over 1,000 PSI, exceeding the capacity of the test apparatus, were typical.

Immediately following the surface preparation, Bridge Preservation™ Multi-Use Primer was installed using hand sprayers and then rolled out to ensure uniform thickness and coverage. After the primer had completely cured, 80 mils of Bridge Preservation™ BDM was installed. As part of Bridge Preservation's comprehensive Quality Control/ Quality Assurance Program, daily QC readings such as environmental conditions and bond strength are taken and recorded. Because of the tenacious bond of BDM to steel, typical bond strength readings were over 1,000 PSI.
